Inspection Report

Property Address: 123 Main St Some Town WA 98038

Full House Inspection Services

Date: 4/17/2015	Time: 02:15 PM	Report ID: 150417-27942
Property: 123 Main St	Customer: Jane Buyer	Real Estate Professional:
Some Town WA 98038	Sanc Buyer

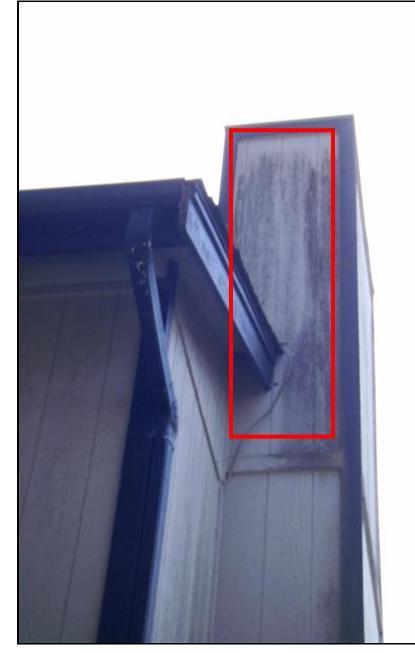
1.2 Item 2(Picture) no drip flashing

The wood siding is deteriorating at the top of the chase. This is due in part to the chimney cap flashing failing to direct water away from the chase. This condition is visible at the north and east faces of the chimney chase. Further deterioration may occur if not repaired. A qualified contractor should inspect and repair as needed.

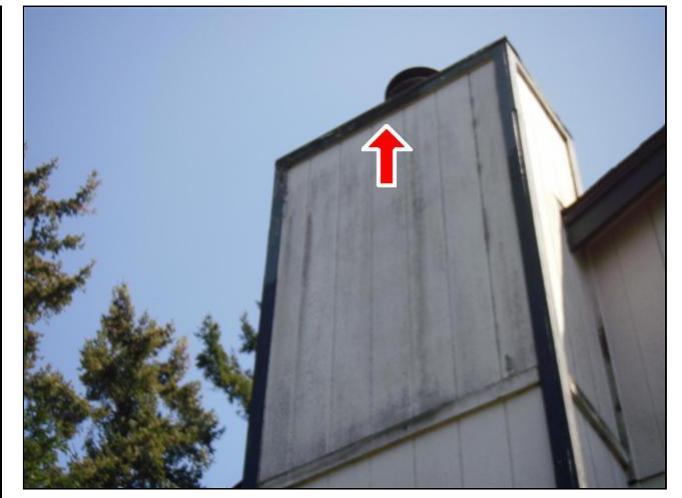
1.2 Item 1(Picture) moisture stains

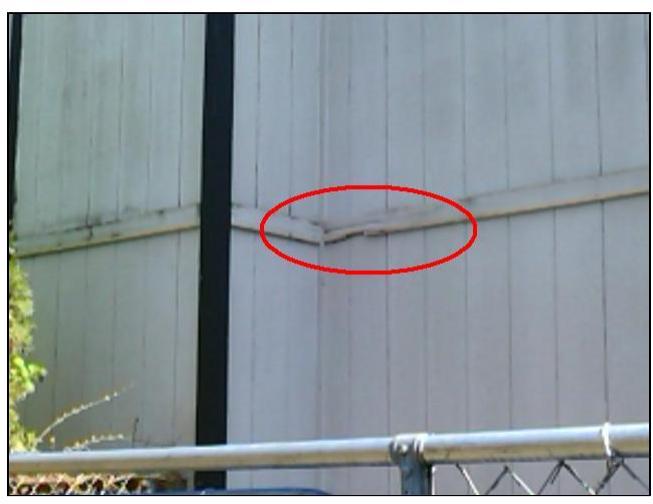
2.0 (1) The Wood trim at the right corner (facing rear) is damaged. Further deterioration can occur if not corrected. A qualified contractor should inspect and repair as needed.

2.0 Item 1(Picture) damaged trim board(s)

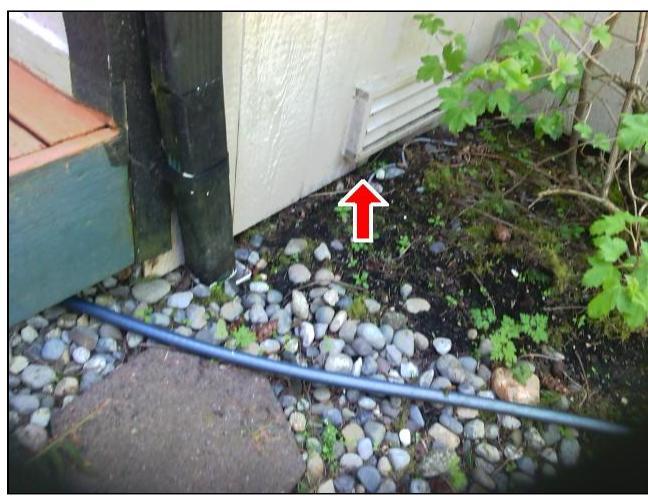
2.0 (2) The composite wood panel siding is in contact with ground at several locations. Further deterioration can occur if not corrected. I recommend removing dirt contact and installing an appropriate skirting to protect the wood from further deterioration.

2.0 Item 2(Picture) earth contact north side

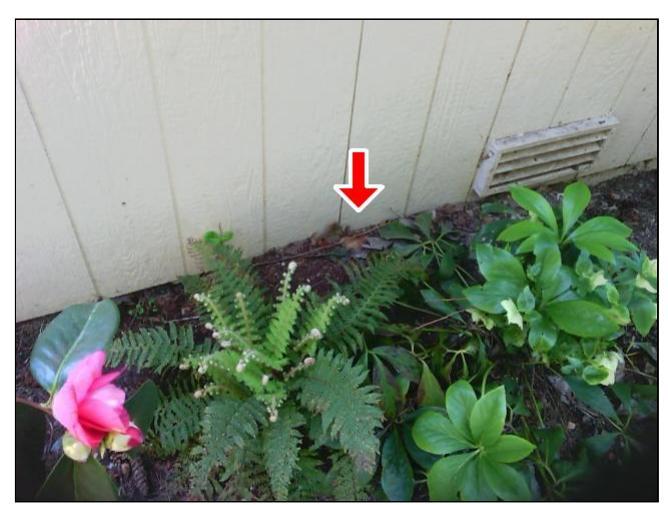
2.0 Item 3(Picture) earth contact east side

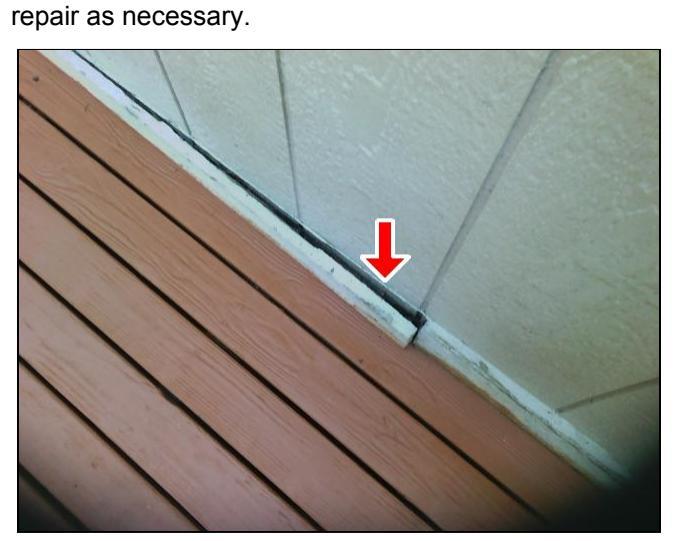
2.0 Item 4(Picture) damaged siding

(3) The wood trim at the rear of the home where siding comes in contact with deck is causing deterioration of the panel siding behind the trim board(s). This application is not desirable because water is trapped between the layers of wood. Further deterioration will occur if not corrected. I recommend an inspection by a competent contractor for investigation and repair as necessary.

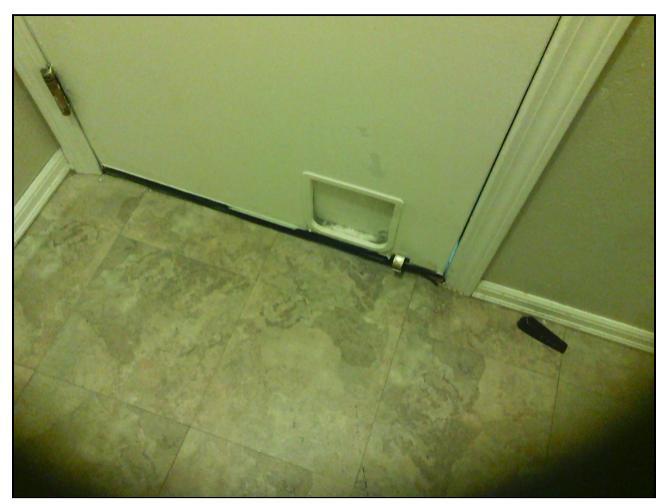
3.4 The occupant door from inside garage to inside the home is not a fire rated door. This means that should a fire occur in garage, the occupant door does not afford protection until fireman arrive. This door should be replaced with a fire rated door.

3.4 Item 1(Picture) compromised garage door

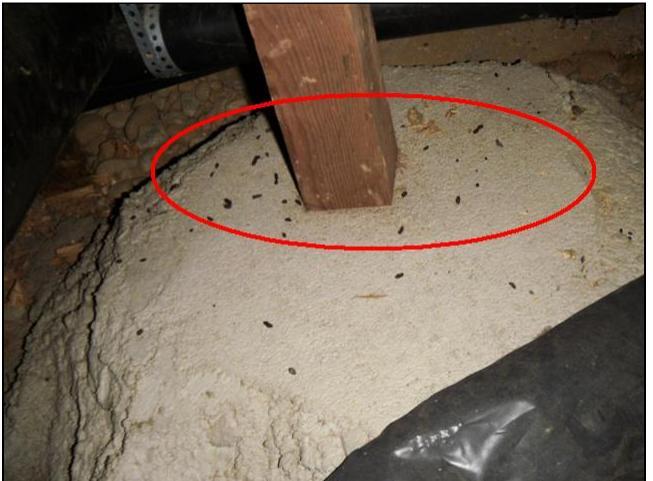
5.0 Item 1(Picture) rodent droppings

There is evidence of past rodent traffic within the crawl space. The condition may not be active however rodent droppings are visible around and on the vapor barrier. I recommend removing and replacing the soiled vapor barrier. Some of the insulation may also be tainted and should be replaced as well.

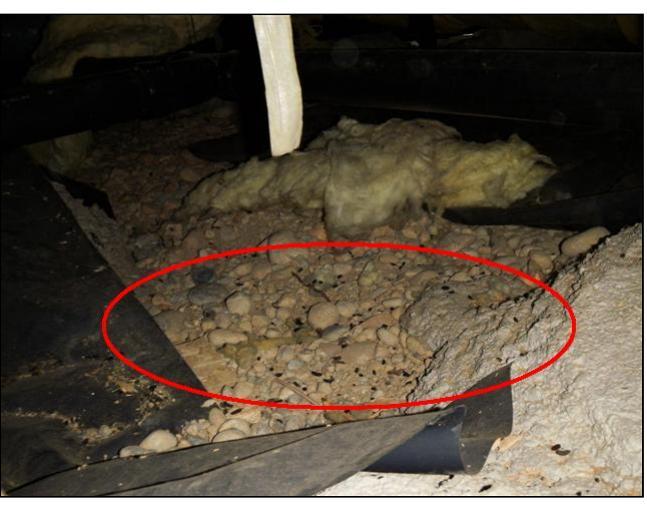
5.0 Item 4(Picture) rodents/missing vapor barrier

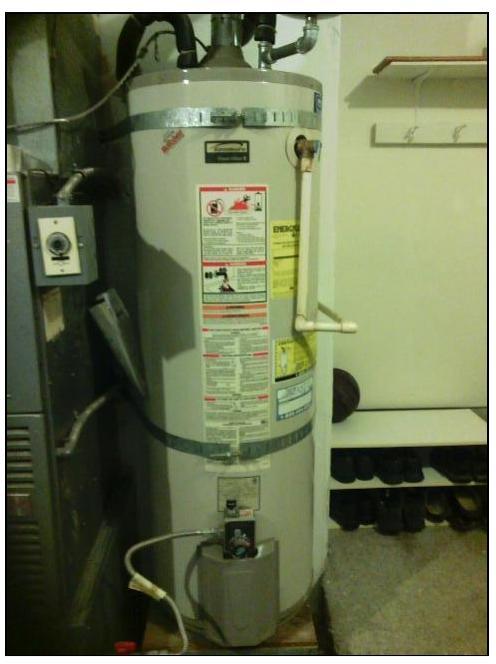
6.2 (1) The water heater is old, rusted and at the end of its life expectancy. No leaks at present. A replacement is needed. A qualified licensed plumber should repair or correct as needed.

6.2 Item 1(Picture) 2002 water heater

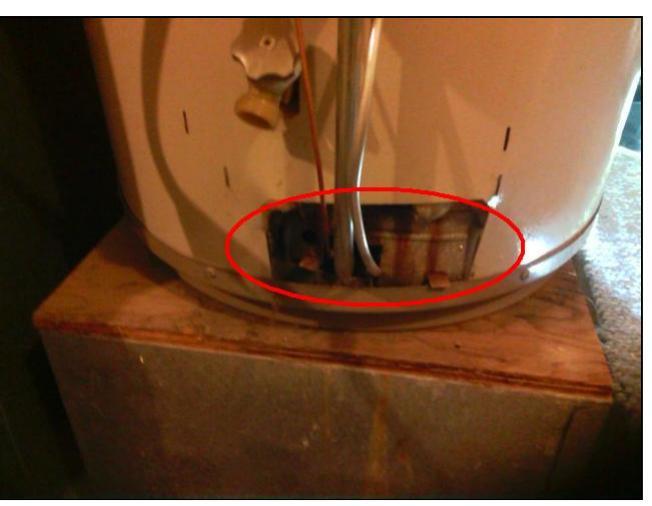
6.2 Item 2(Picture) water tracks

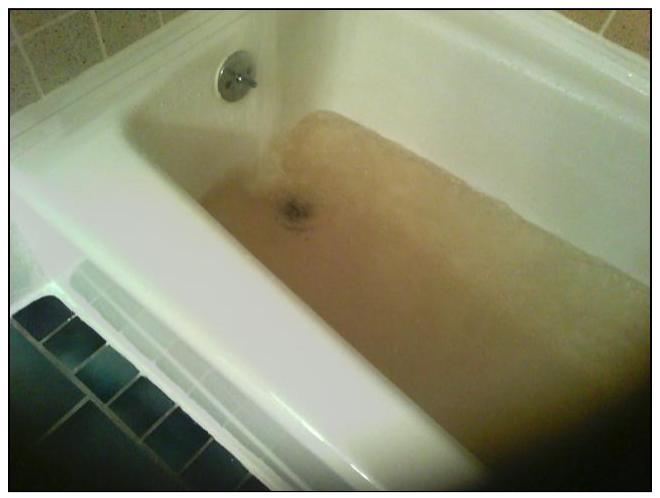
6.2 (2) Due to the age of the water heater, some fixtures are delivering rusty looking water due to corrosion within the storage tank.

6.2 Item 3(Picture) rusty water

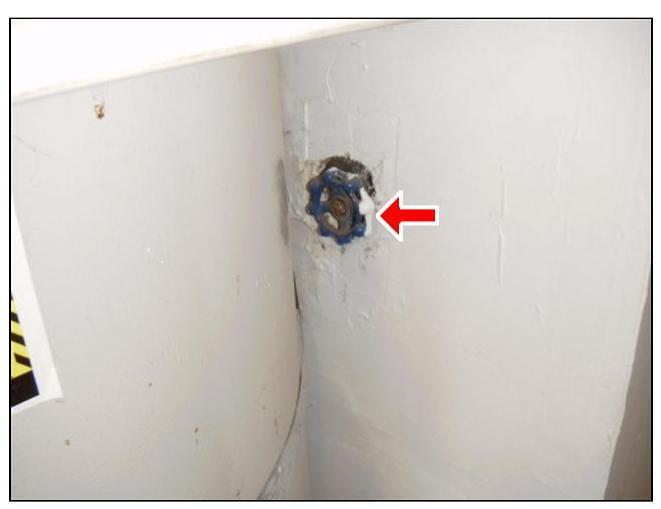
6.3 (1) The main water shut-off valve is located behind the water heater within the garage.

6.3 Item 1(Picture) water main

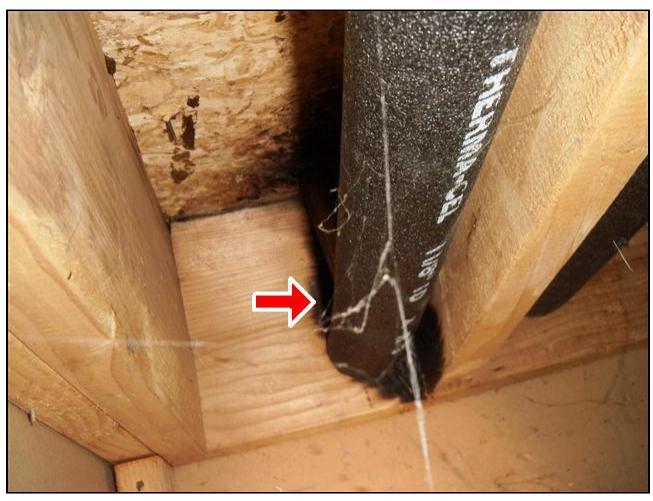
6.3 (2) A dark spot was noted on the subfloor beneath the water shutoff as viewed from the crawl space. On further review, this appears to be an original burn mark from when the copper pipes were sweated.

6.3 Item 2(Picture) burn marks

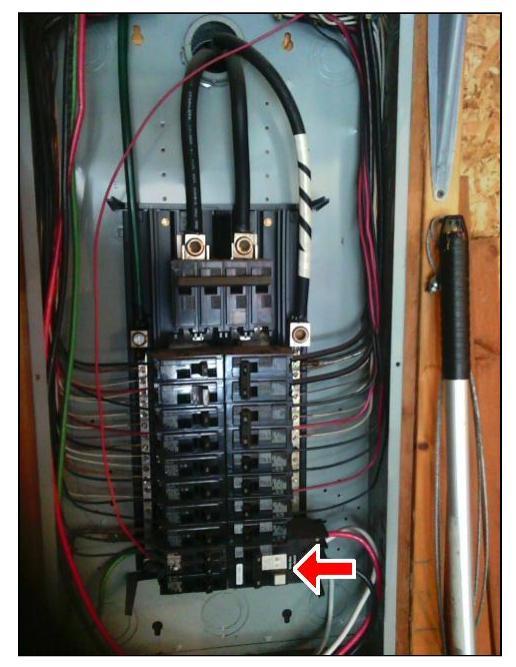
200 amp service/ trip for hot tub

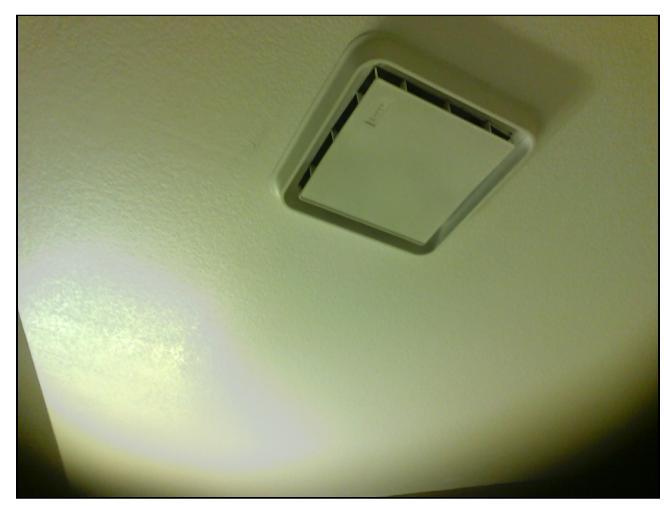
7.2 (1) The bath exhaust fan in main floor bath is noisy. The motor may be wearing out, or the fan blade needs adjusting. Regardless, you may wish to replace this fan with a quieter one.

7.2 Item 1(Picture) noisy fan

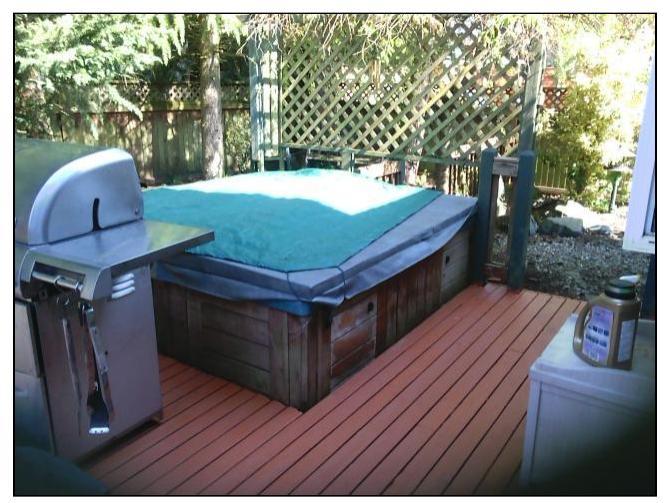
7.2 (2) The hot tub GFCI protection is located at the service panel. Ideally this safety feature should be located within 5 feet of the tub.

7.2 Item 2(Picture) hot tub

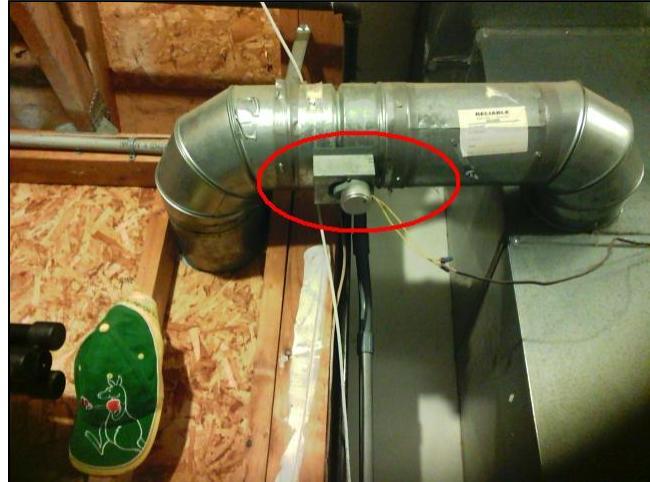
8.0 (1) The fresh air intake circulating fan is not functioning. I recommend repair/replacement as necessary.

8.0 Item 1(Picture) inducer

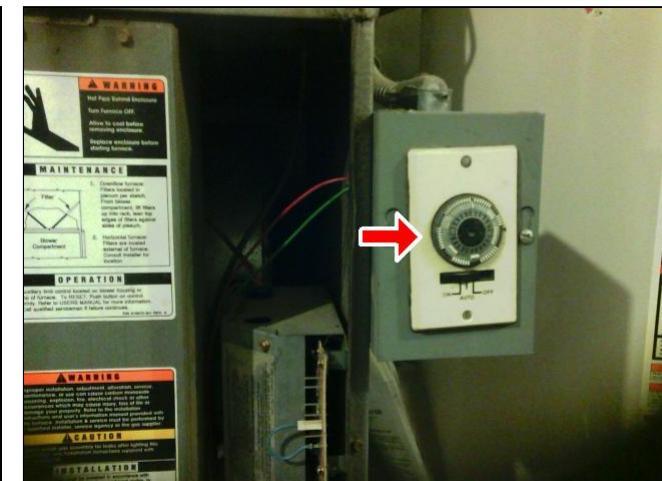
8.0 Item 2(Picture) control timer for air intake

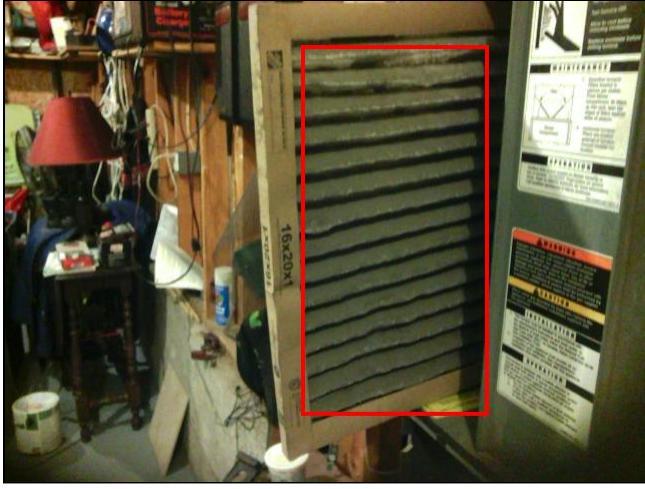
8.0 (2) The furnace filter(s) are filthy which indicates a lack of maintenance. There is no record of maintenance service which I recommend prior to closing. The furnace is old (original 1992 model), and I am not able to determine its remaining life. You may want to budget for a replacement in the near future.

8.0 Item 3(Picture) sample dirty filter

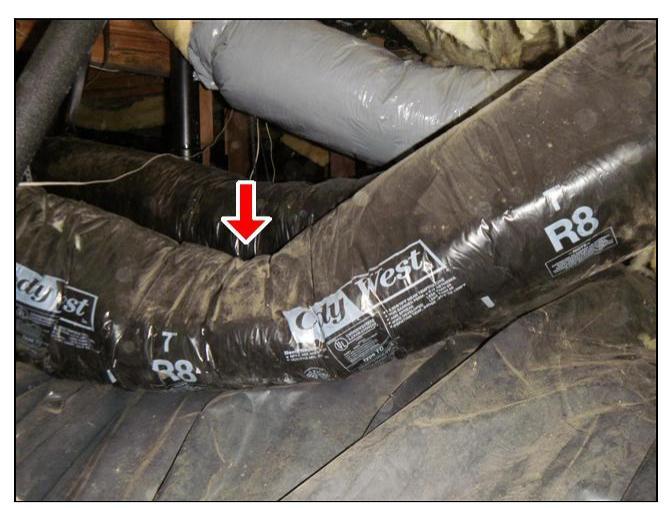
8.3 The one the insulated heat ducts near the north perimeter is in contact with the ground and has restricted flow. I recommend restraning the flexible duct so that there is at least a 4 inch clearance from the ground.

8.3 Item 1(Picture) collapsed heat duct

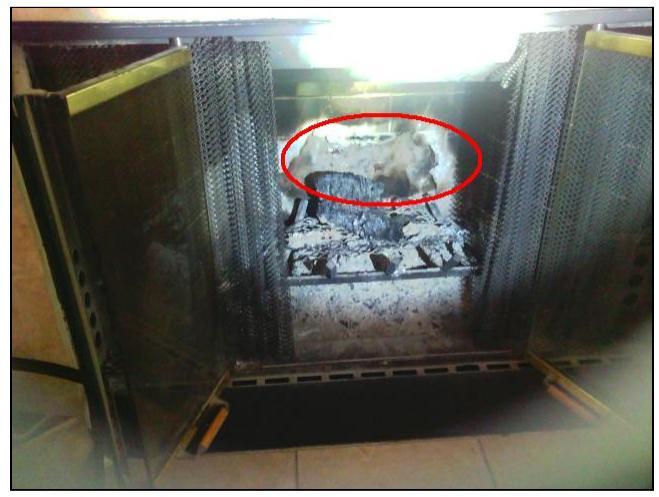
8.6 The fire brick within the fireplace is damaged. This is for your information. I recommend that the chimney flue be inspected and cleaned by a chimney sweep prior to using the fireplace.

8.6 Item 1(Picture) damaged fire brick

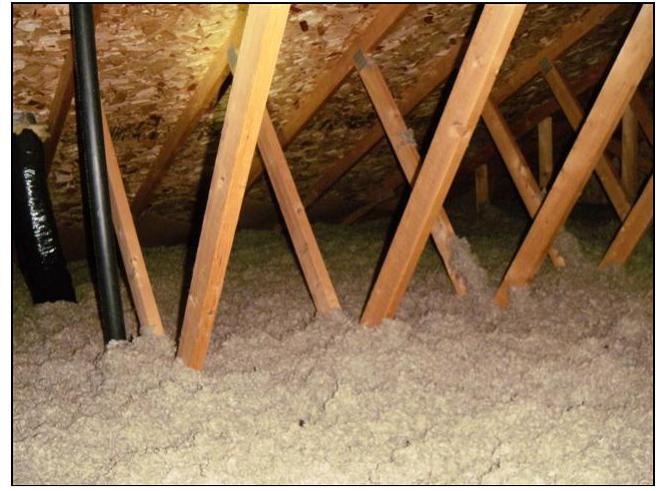
9.0 Cellulose insulation is about nine inches thick or just under 33 R-Value.

9.0 Item 1(Picture) attic insulation level

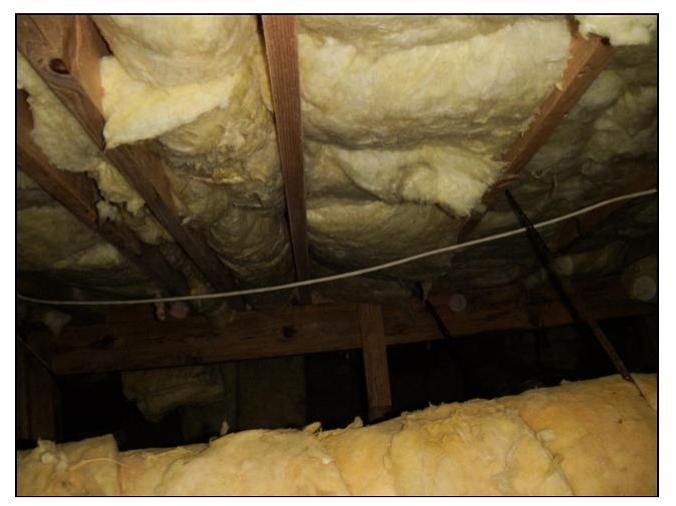
9.1 The floor insulation is 6 inch unfaced batts, or about R 19. Some of the insulation has come loose or fallen down. You may wish to have the insulation re-installed.

9.1 Item 1(Picture) R 19 insulation

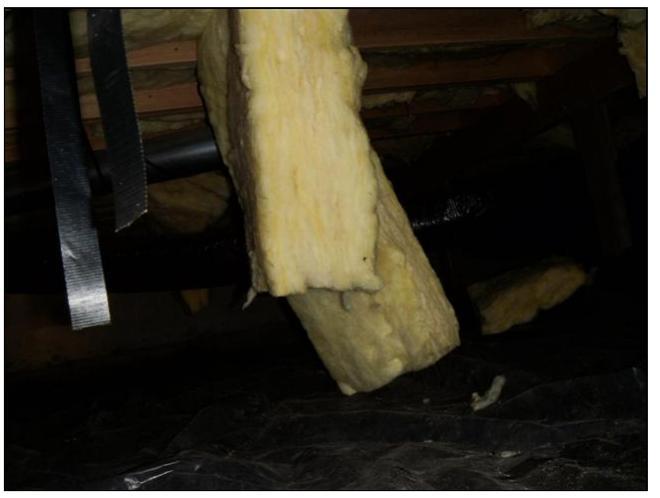
9.1 Item 2(Picture) loose insulation

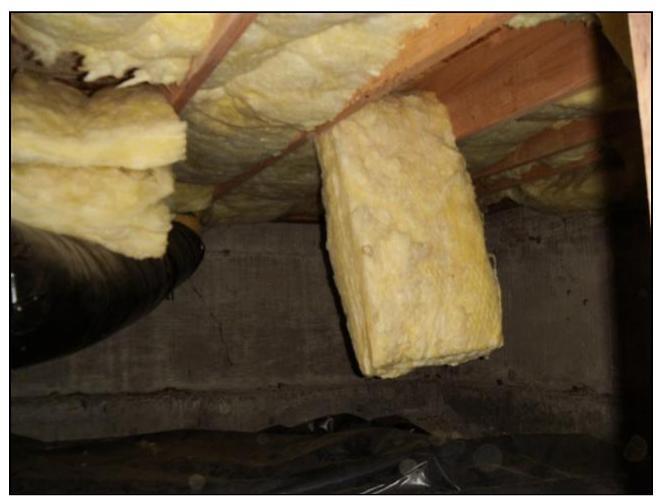
9.1 Item 3(Picture) loose insulation

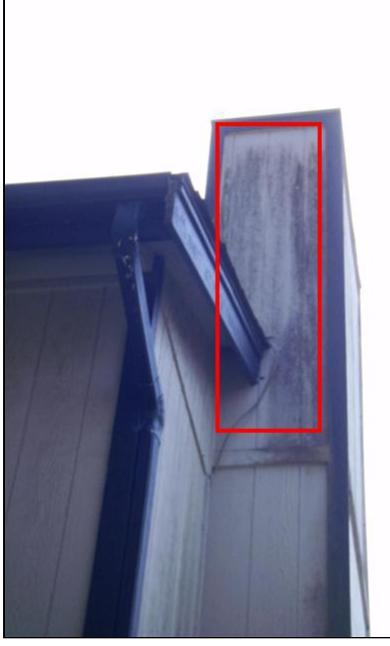
1.2 Item 2(Picture) no drip flashing

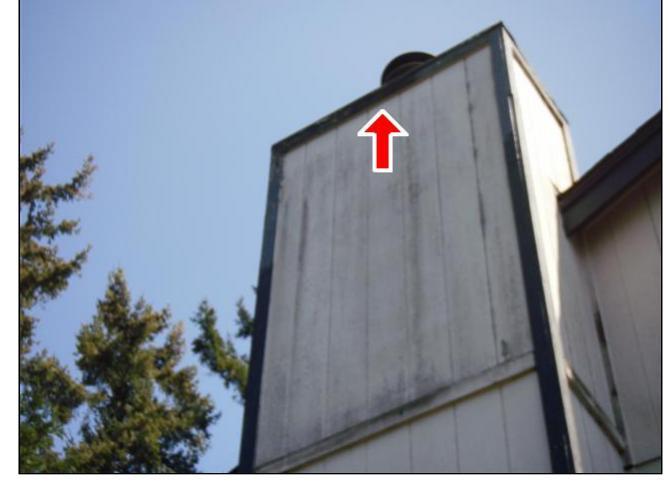
1.2 Item 1(Picture) moisture stains

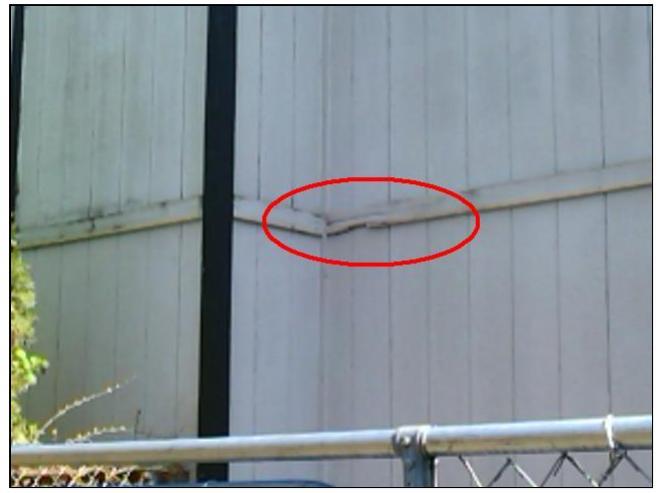
(1) The Wood trim at the right corner (facing rear) is damaged. Further deterioration can occur if not corrected. A qualified contractor should inspect and repair as needed.

2.0 Item 1(Picture) damaged trim board(s)

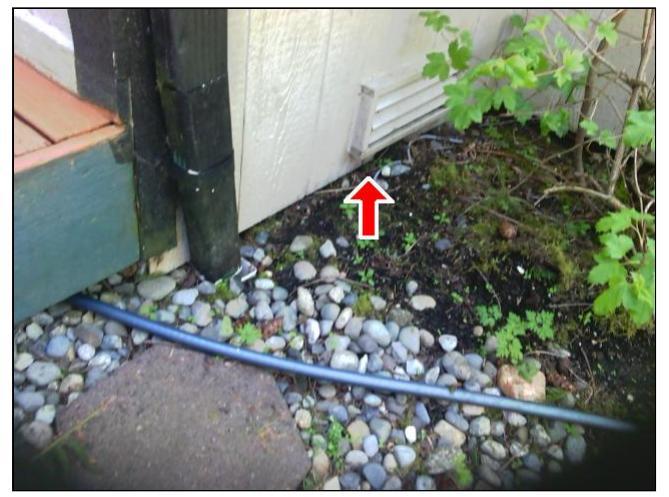
(2) The composite wood panel siding is in contact with ground at several locations. Further deterioration can occur if not corrected. I recommend removing dirt contact and installing an appropriate skirting to protect the wood from further deterioration.

2.0 Item 2(Picture) earth contact north side

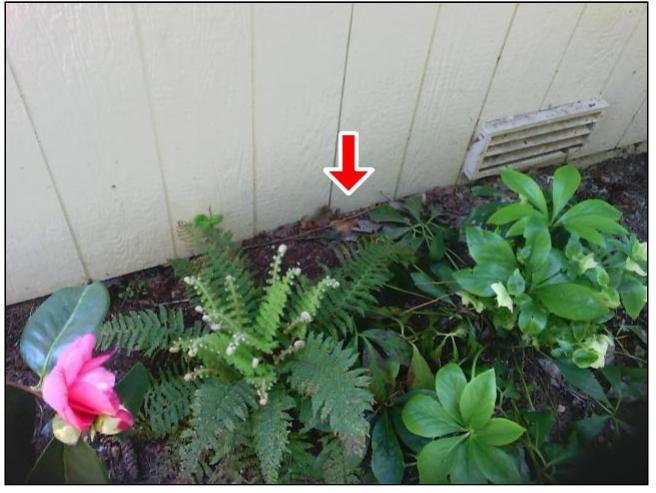
2.0 Item 3(Picture) earth contact east side

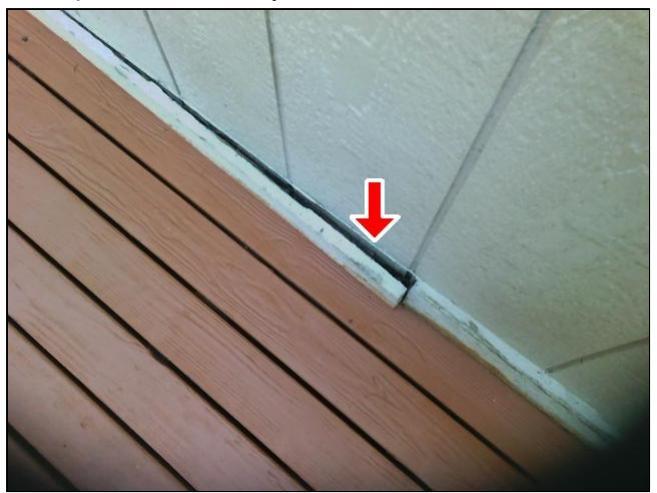
2.0 Item 4(Picture) damaged siding

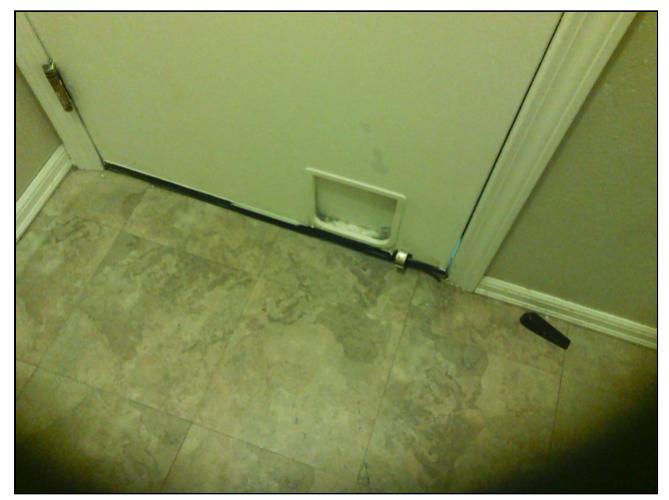
The occupant door from inside garage to inside the home is not a fire rated door. This means that should a fire occur in garage, the occupant door does not afford protection until fireman arrive. This door should be replaced with a fire rated door.

3.4 Item 1(Picture) compromised garage door

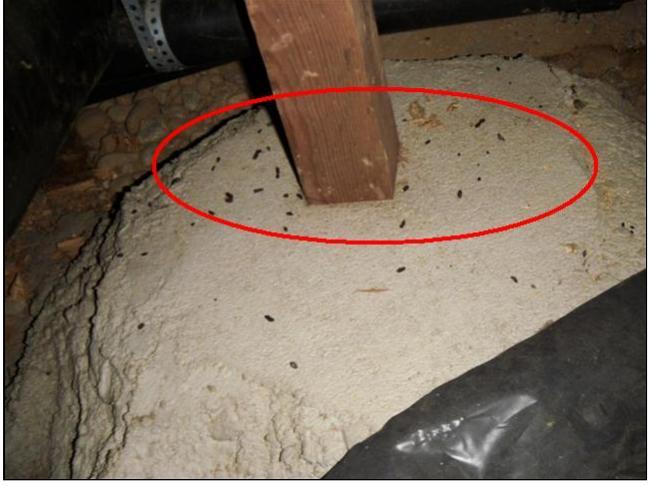
5.0 Item 1(Picture) rodent droppings

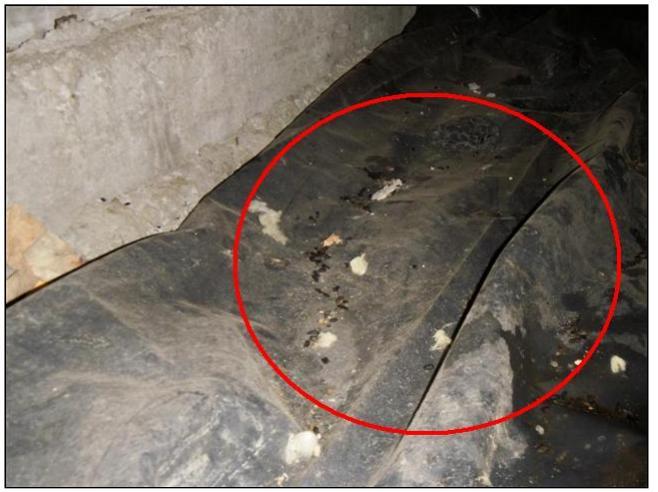
5.0 Item 2(Picture) rodent traffic

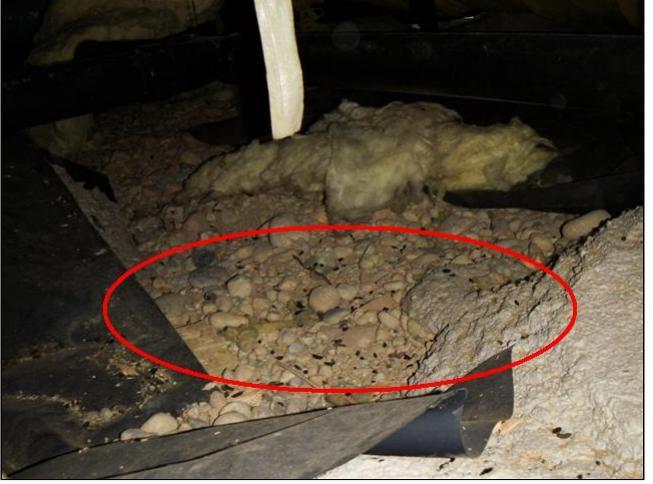
5.0 Item 4(Picture) rodents/missing vapor barrier

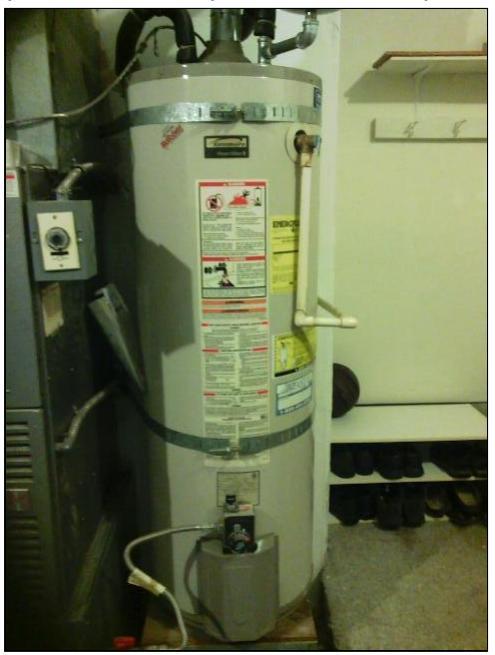
(1) The water heater is old, rusted and at the end of its life expectancy. No leaks at present. A replacement is needed. A qualified licensed plumber should repair or correct as needed.

6.2 Item 1(Picture) 2002 water heater

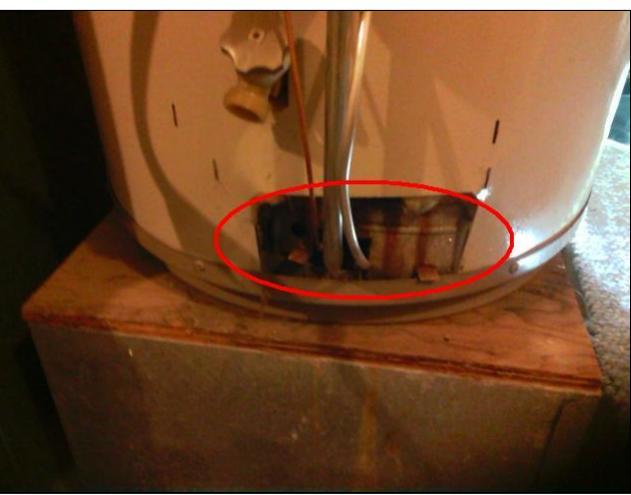
6.2 Item 2(Picture) water tracks

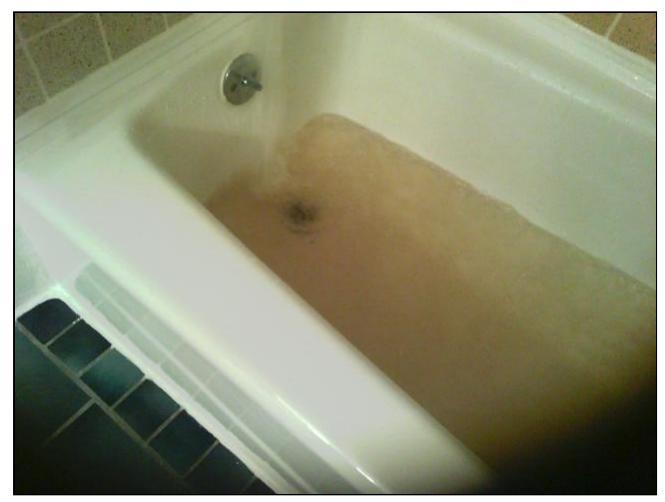
(2) Due to the age of the water heater, some fixtures are delivering rusty looking water due to corrosion within the storage tank.

6.2 Item 3(Picture) rusty water

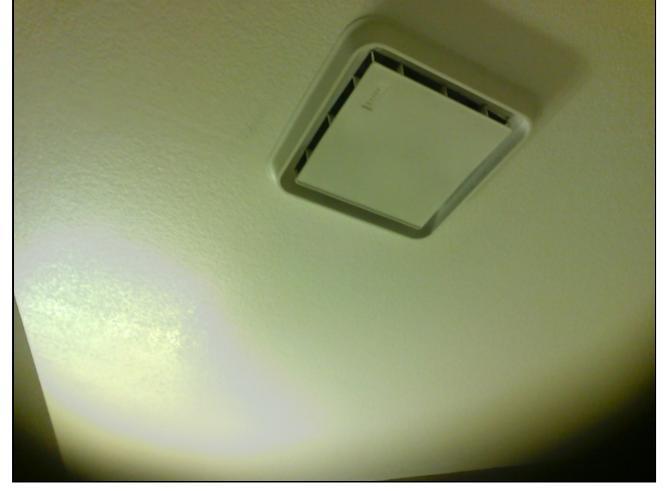
(1) The bath exhaust fan in main floor bath is noisy. The motor may be wearing out, or the fan blade needs adjusting. Regardless, you may wish to replace this fan with a quieter one.

7.2 Item 1(Picture) noisy fan

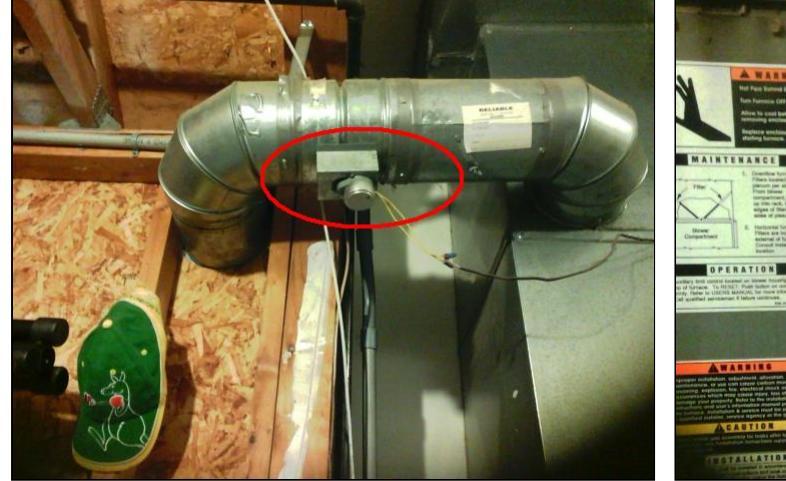
(1) The fresh air intake circulating fan is not functioning. I recommend repair/replacement as necessary.

8.0 Item 1(Picture) inducer

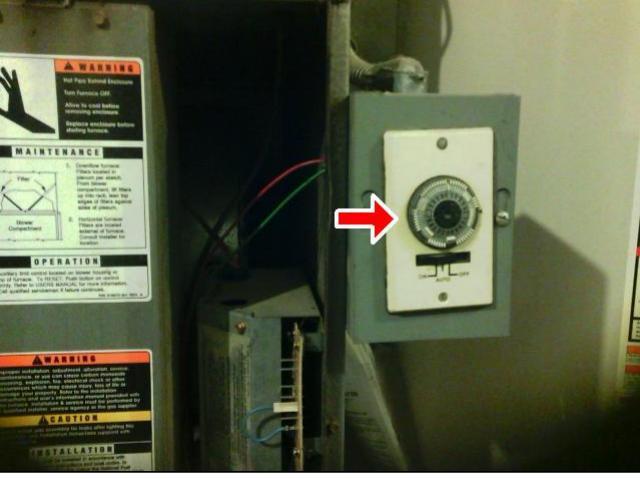
8.0 Item 2(Picture) control timer for air intake

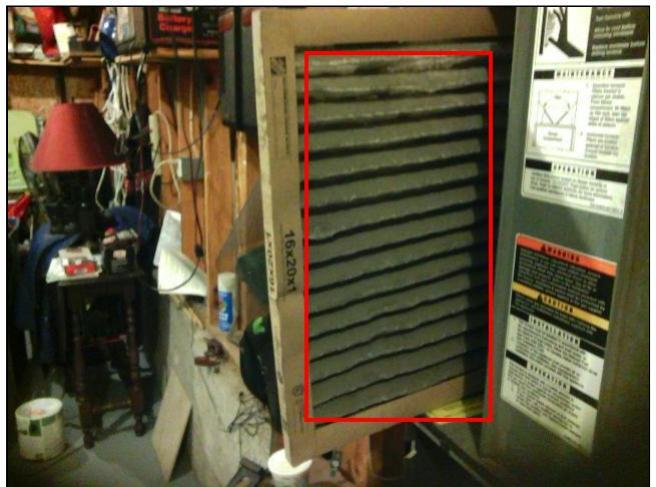
(2) The furnace filter(s) are filthy which indicates a lack of maintenance. There is no record of maintenance service which I recommend prior to closing. The furnace is old (original 1992 model), and I am not able to determine its remaining life. You may want to budget for a replacement in the near future.

8.0 Item 3(Picture) sample dirty filter

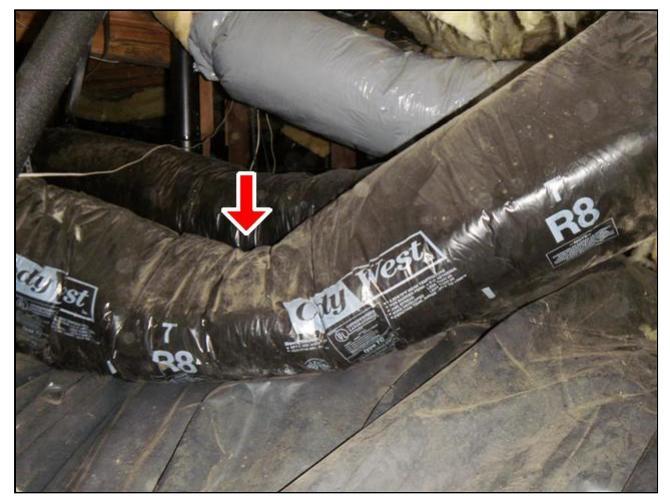
The one the insulated heat ducts near the north perimeter is in contact with the ground and has restricted flow. I recommend restraning the flexible duct so that there is at least a 4 inch clearance from the ground.

8.3 Item 1(Picture) collapsed heat duct
